Manhole Inspection Summary

Manhole # S23KK_011MH

Location Address: **2500 PENNSYLVANIA AVE**

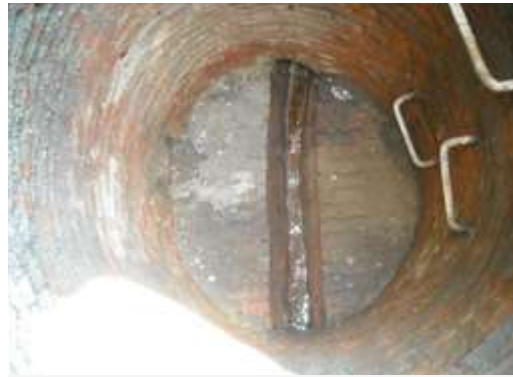
Top View

Barrel infiltration. Bench debris.

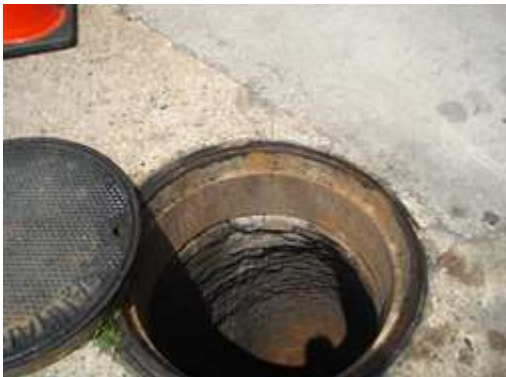
Defect

Frame leaks. Corbel deterioration and infiltration.

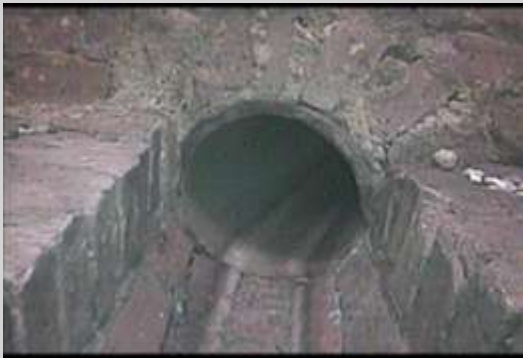
8 in. Circular Gravity Sewer Pipe Out @ 12 O'Clock

Infiltration: **Evidence** Pipe Seal Cond: **Unknown**
